FIELD INVESTIGATION
of
ATLAS ASBESTOS
and
COALINGA ASBESTOS MINES

Date of Investigation: May 19 to 21, 1980

This is an ~~in-progress~~ report of asbestos contamination of streams in the Atlas Mine and Coalinga Mine areas. It is based on a field inspection of the area conducted on May 19 to May 21, 1980. This report contains the results of laboratory analysis which were available as of July 22, 1980.

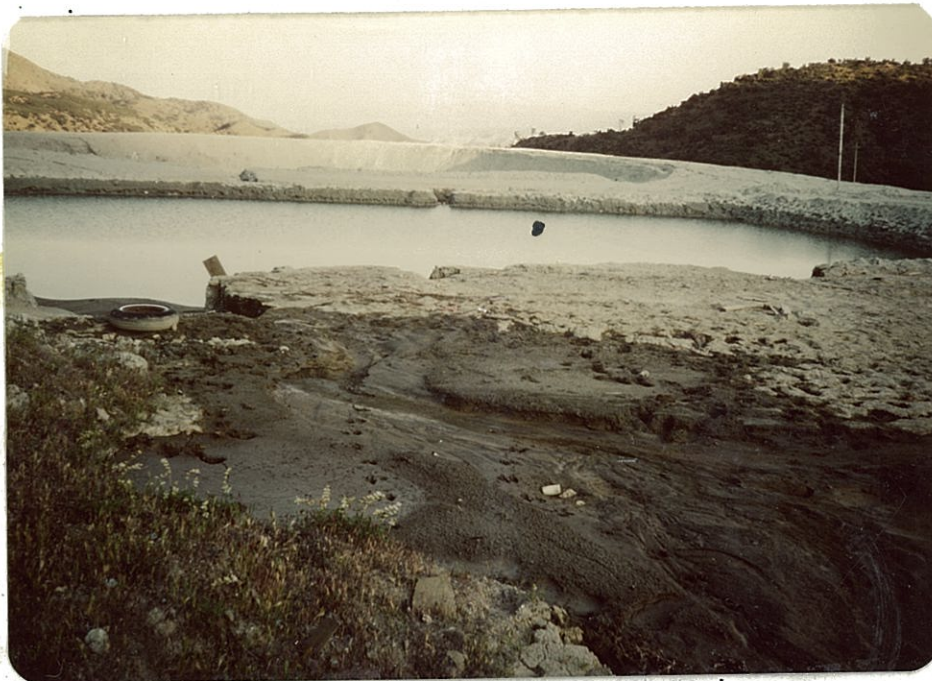
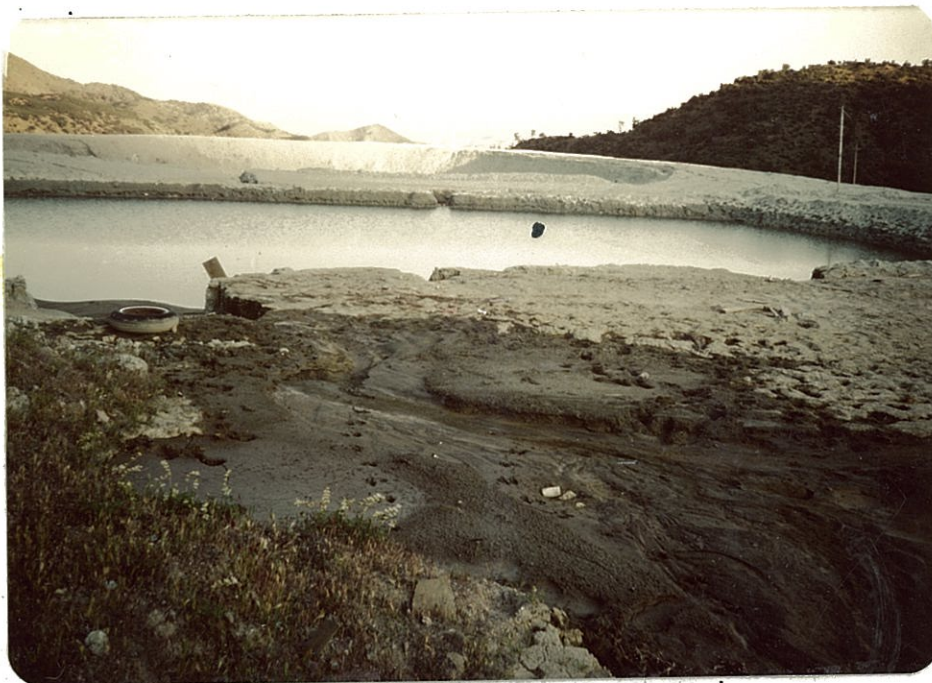
No. C12 Subject: Coaling Asbestos Tailings pile.
This photo shows one of the Erosion Control dams.
Facility: Coalinga Mine

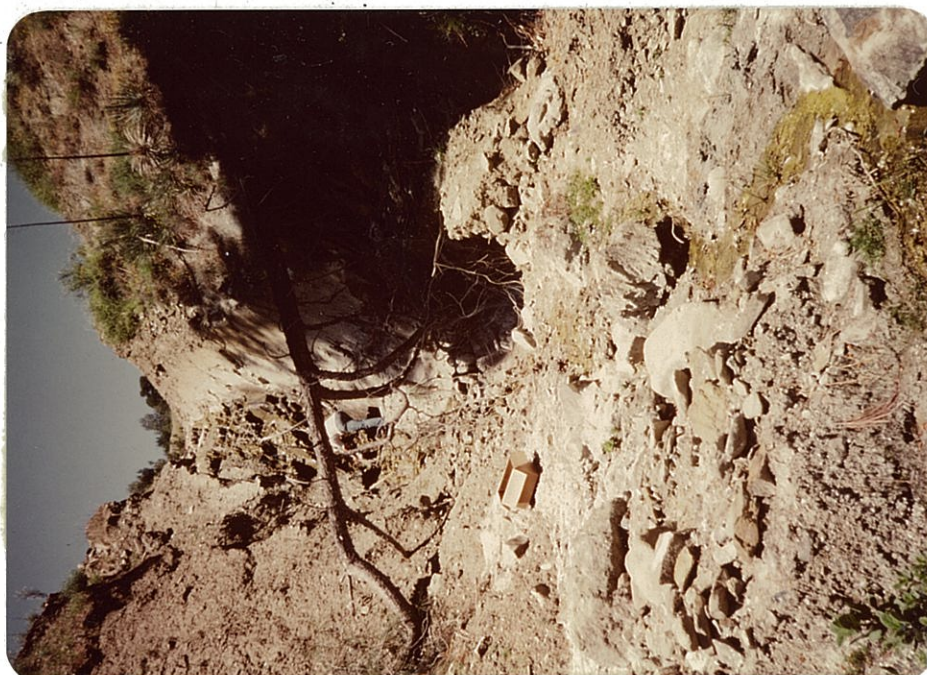
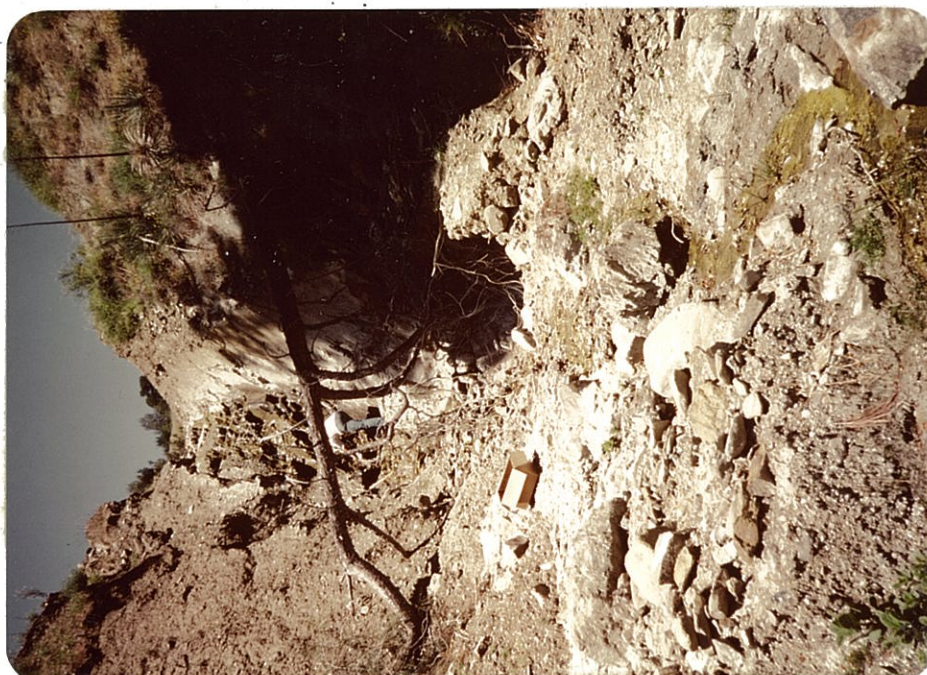
No. C13 Subject: Collecting a sample from the bottom
of the dam below the Coalinga Tailings pile. Note
the erosion.
Facility: Coalinga Mine

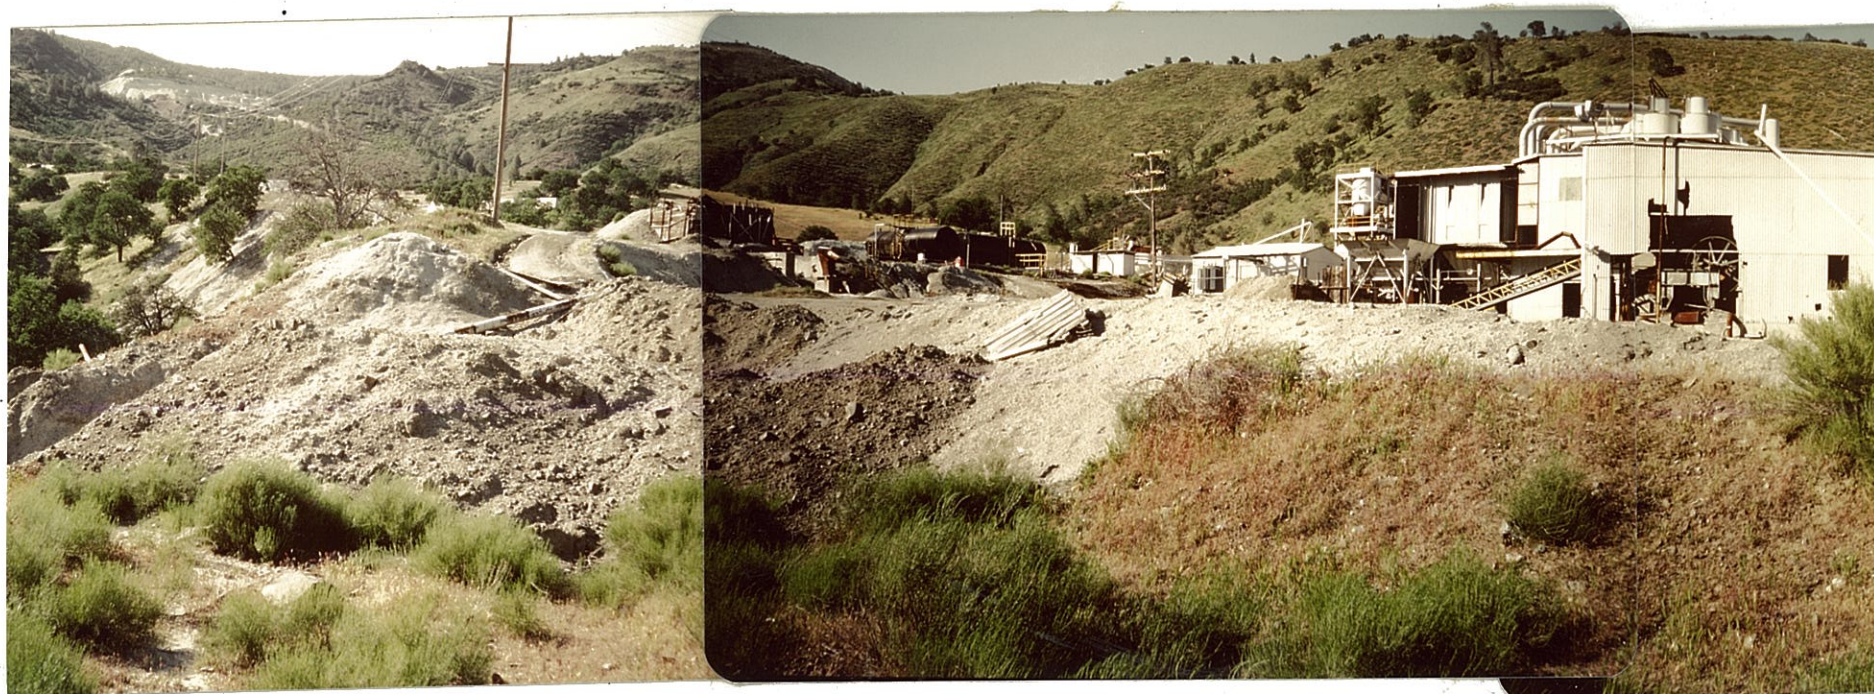
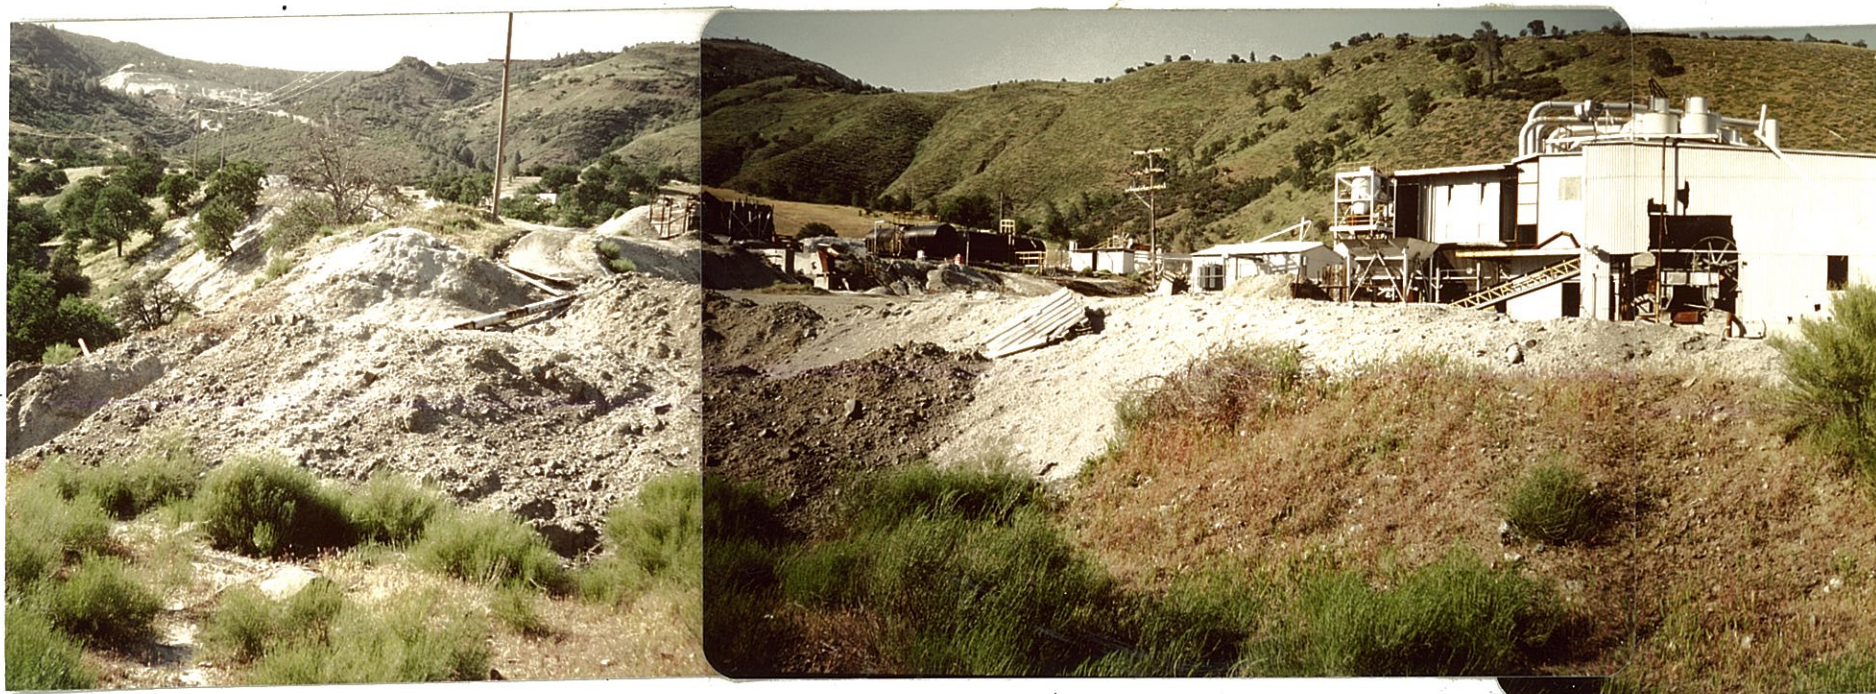
No. C16, C17, C18

Subject: Coalinga Mine Mill. Note the barren area in
the upper left corner. This is a mining area.
